PITOTSHIELDS™
SAFETY PITOT COVERS

PitotShield V2™ Detaining Bridle Instructions

OVERVIEW OF THE PSV2™ DETAINING BRIDLE

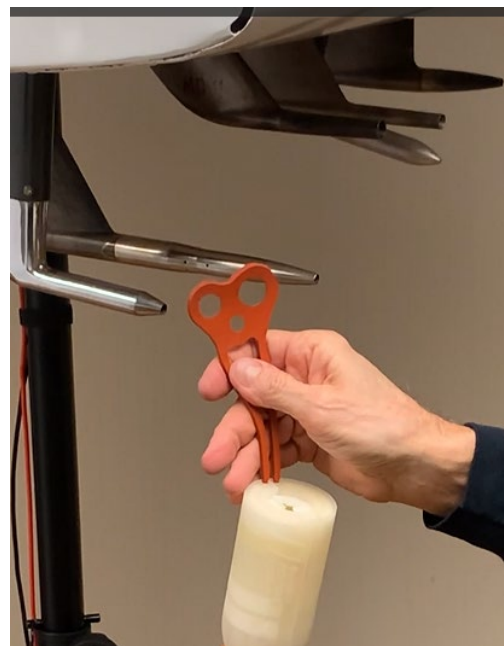
Fig 2

Place the bridle head up to the pitot tube (Fig 2) to determine which hole most closely measures approximately 1/16" to 1/8" smaller than the pitot tube diameter at approximately three inches back from the tip.

Using both hands, grasp the head of the bridle on either side of the appropriate hole, with the PitotShield body oriented as shown in fig 2. Slide the bridle onto the pitot tube (Fig 3) to about 3 ½ inches from the pitot tube tip (fig 4). The bridle should slide onto the pitot tube with slightly firm resistance.

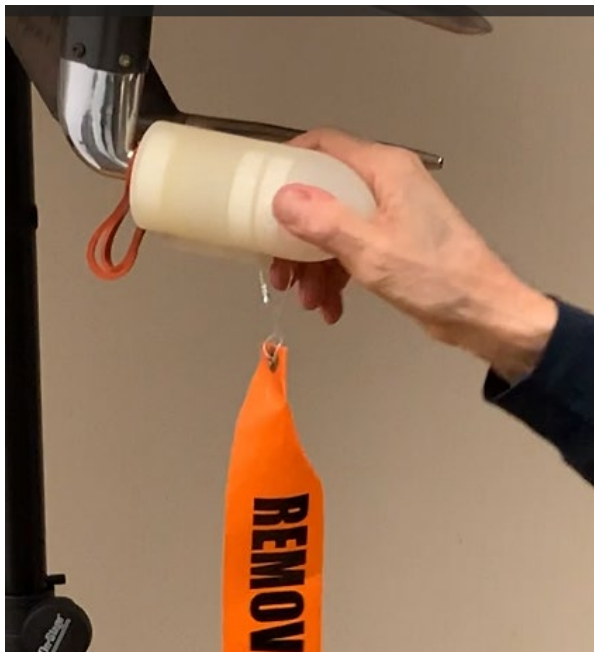
Fig. 5

Grasp the PitotShield with the RBF Streamer oriented down, assuring the Bridle Arms are not crossed, and slide the PitotShield V2™ onto the pitot tube until a hard stop is felt (Fig. 5). Your pitot tube is now protected.

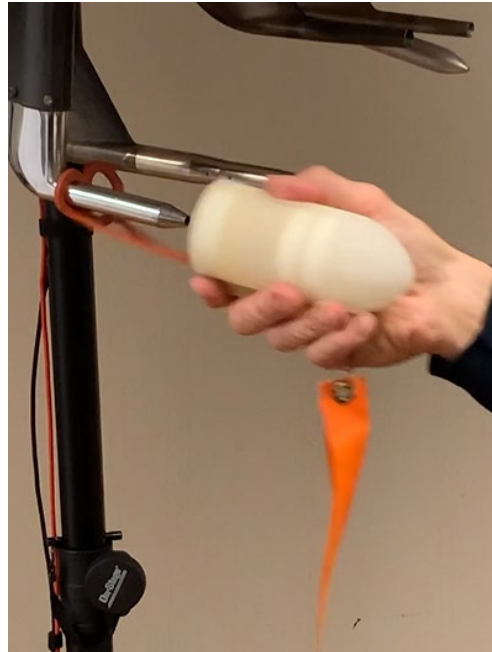
Fig. 6

After confirming the pitot heat is off and the pitot tube is cool, grasp the PitotShield body (Fig 6) and pull straight forward, off the pitot tube just until the back of the cover is clear of the pitot tube tip. Then, allowing the pitot tube to hang by the Bridle Arms, using two hands (Fig 4), slide the bridle forward and off the pitot tube.

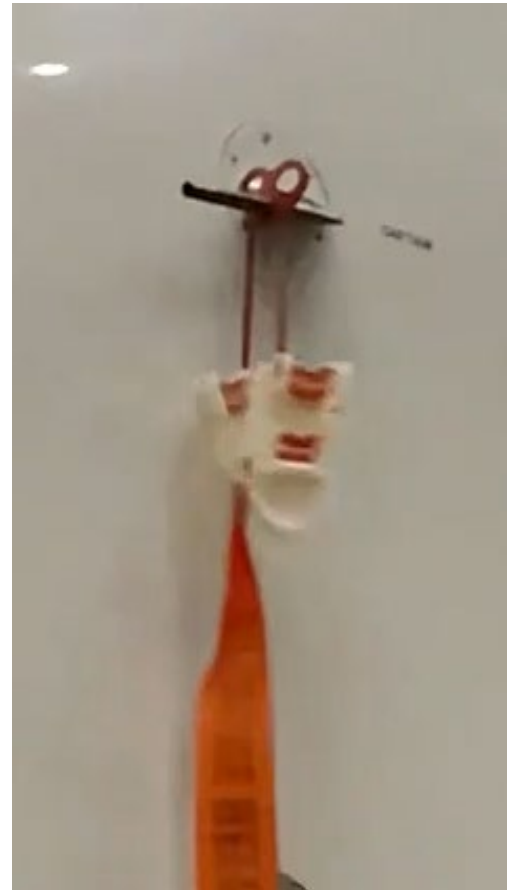
Fig. 7

If the pitot heat has been activated and the PitotShield V2 has deployed and hanging by the Bridle (Fig 7), confirm pitot heat is off and the pitot tube is cool. The Bridle can then be carefully removed using two hands as described above.

Note that some pitot heat systems are such that their pitot tube temperatures are sufficient to degrade the bridle surface contacting the pitot tube. Crystallization or powdering and/or splits may appear on the bridle hole edges, indicating that its tensile strength will be compromised, particularly while the silicone is hot. This indicates a possibility of the bridle tearing at the hole with further use. Thus, after a thermal ejection, inspect the bridle and replace with new (DAT P/N 77-DBU1) if degradation is observed.
